INSPECTION FINDINGS

BURLINGTON CITY PROMENADE
ALONG DELAWARE RIVER
BURLINGTON CITY, NJ

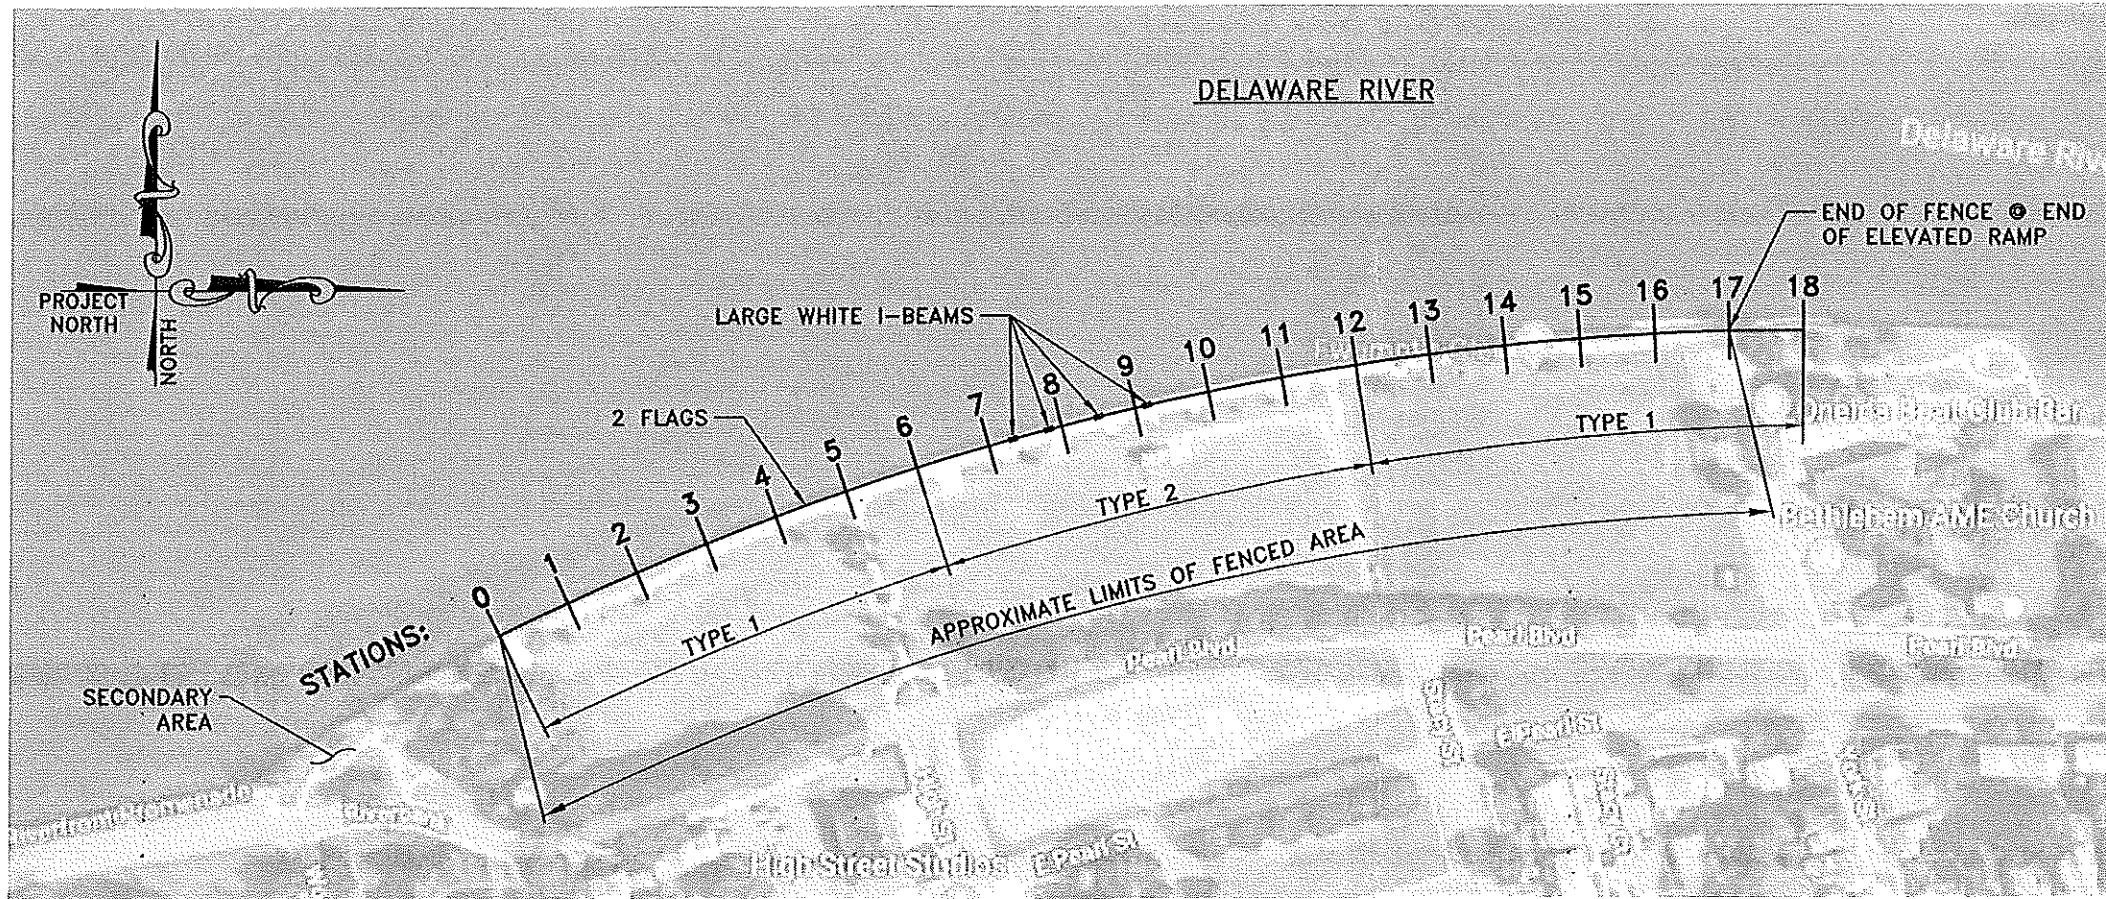
PLAN VIEW
SCALE: N.T.S.

SOUNDING TABLE	
STATION	CHANNEL BOTTOM ELEVATIONS
0	-11.7
1	-11.8
2	-11.9
3	-12.0
4	-12.4
5	-12.7
6	-13.0
7	-12.6
8	-16.3
9	-18.2
10	-16.3
11	-16.8
12	-15.8
13	-14.7
14	-14.0
15	-13.9
16	-14.1
17	-14.7
18	-15.9

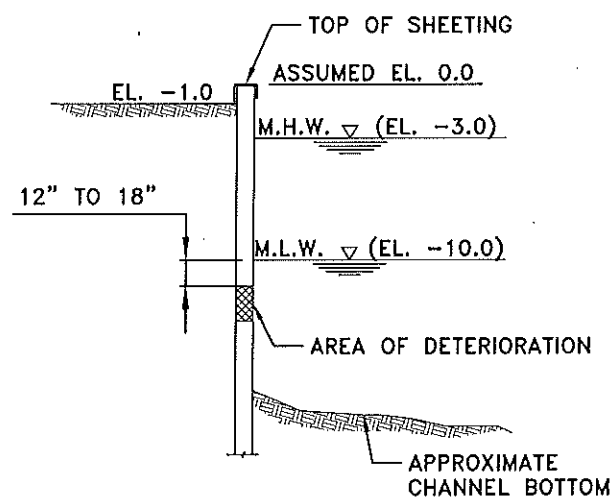
TYPICAL SECTION
SCALE: N.T.S.

DETERIORATION TABLE			
DETERIORATION TYPE	STATIONS	ELEVATIONS	DESCRIPTION
TYPICAL	ALL	-6.0 TO -9.0	LIGHT TO MODERATE SURFACE CORROSION WITH PAINT LOSS
TYPICAL	ALL	-10 TO -11.5	LIGHT NODULES OF MIC DETECTED (UP TO 3/4"Ø WITH NO SECTION LOSS)
TYPE 1	1 TO 6 & 12 TO 18	-11.5 TO -12.5	BAND OF 3/4" TO 1.5"Ø HOLES IN THE SHEETING
TYPE 2	6 TO 12	-11.5 TO -13.0	HOLES IN SHEETING TYPICALLY 6" TO 8"Ø WITH SIGNIFICANT LOSS OF FILL
